Skipping An Attic Inspection Could Be Costly

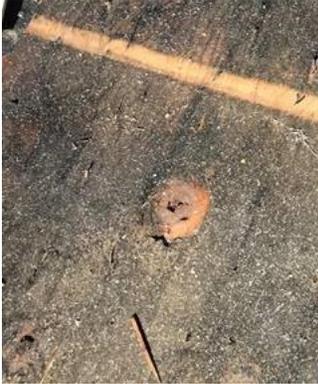
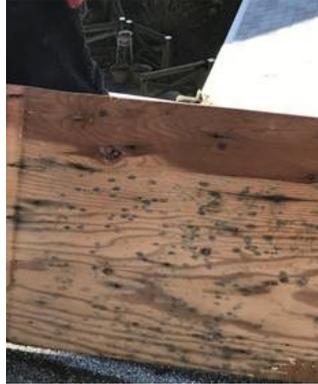
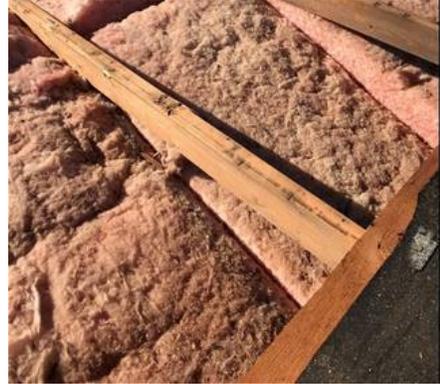
Called back to the house by the homeowner, Pond Roofing Company discovered the insulation packed against the plywood near the eaves inside the attic and multiple signs of excessive moisture. Soon after, Pond Roofing Company would be replacing the roof out of pocket. Photos courtesy of Pond Roofing Company, Fairfax, VA.

Upon further inspection, the power fan had zero intake airflow because inside the attic the insulation was completely blocking the vented soffit. That set the stage for a complete roof replacement paid for out of pocket by Pond Roofing Company. Listen to Pond Roofing Company owner Patrick Readyhough share his company's lesson learned - and the corrective measures his company has taken to never let this happen again - in our latest [podcast](#).
