PERFORMANCE TEST REPORT

AIR VENT, INC.

SERIES/MODEL: Hip Ridge™ Vent

Report No.: A3223.01-801-44
Start Test Date: 03/23/11
End Test Date: 03/24/11
Report Date: 04/25/11
Expiration Date: 03/24/21

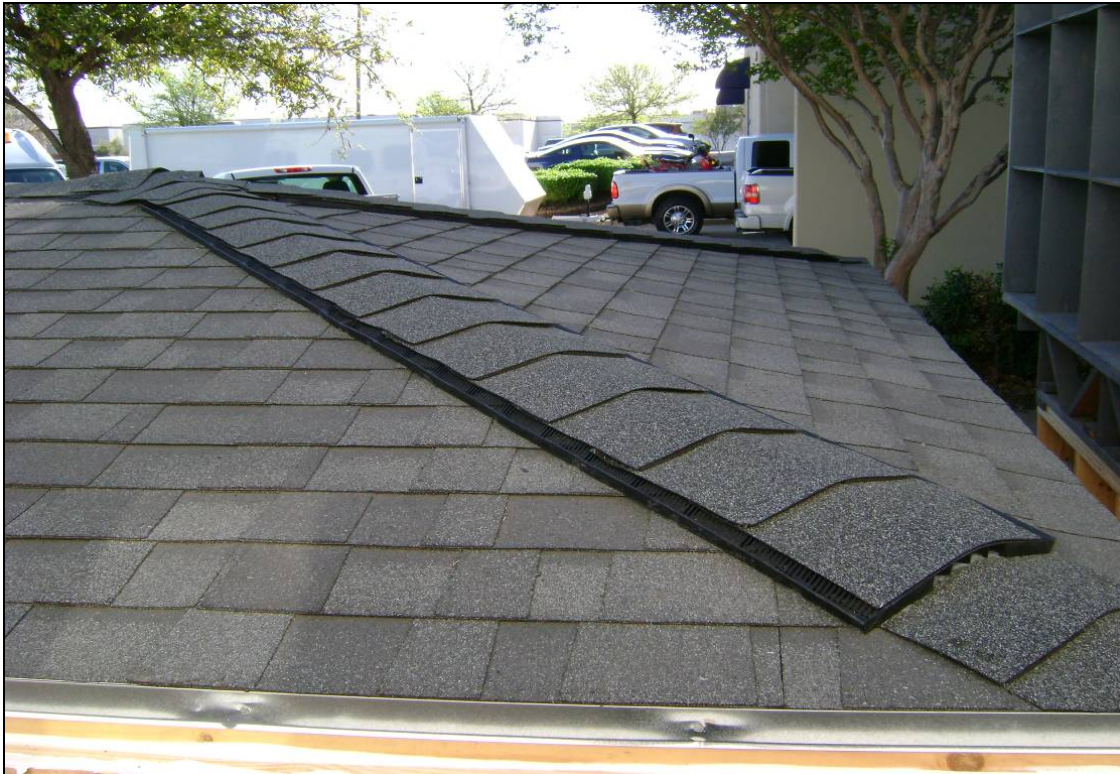
Photo No. 1: Specimen #1 - Wind stream 45° to vent prior to testing

Test #1: (Positioned 45° to wind stream)

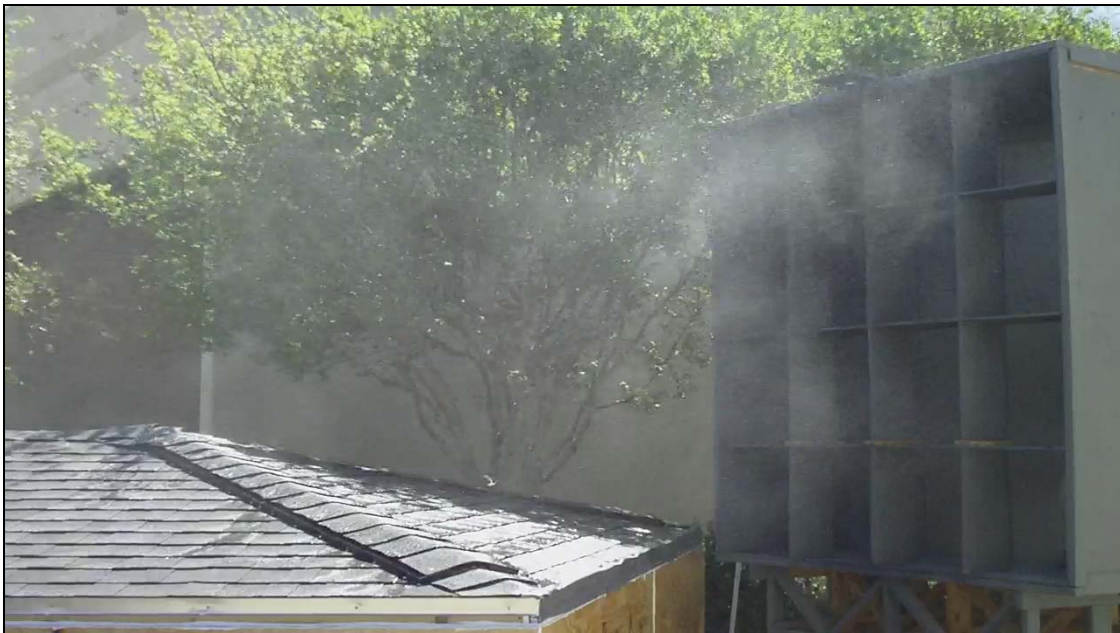
Photo No. 2: Specimen #1 - Wind stream parallel and perpendicular to vents

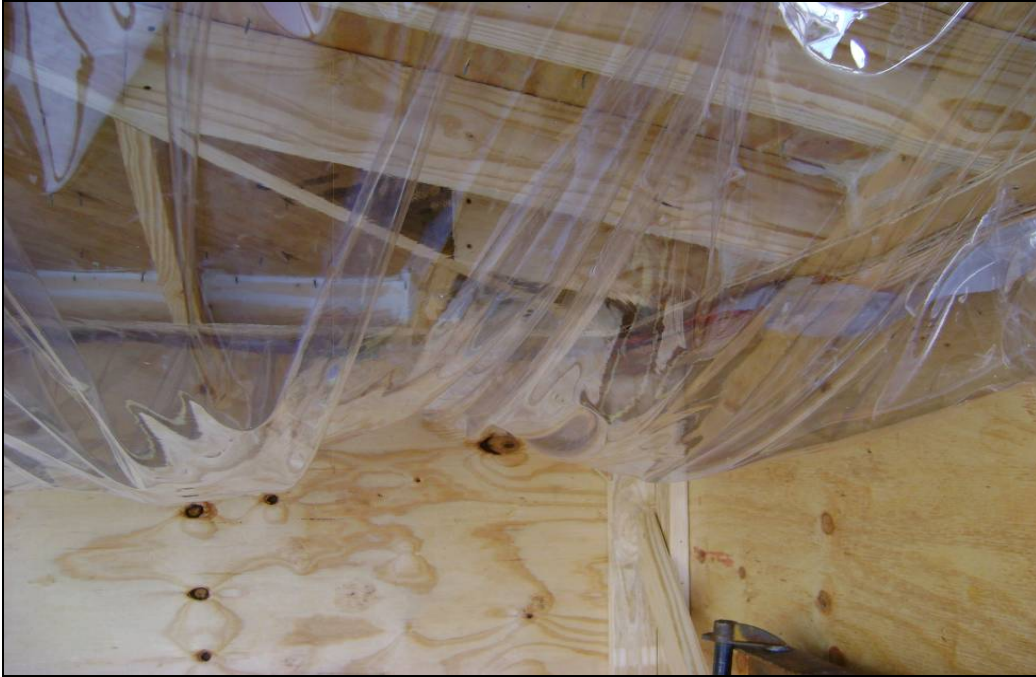
Photo No. 3: Water collection system under test deck at the conclusion of testing

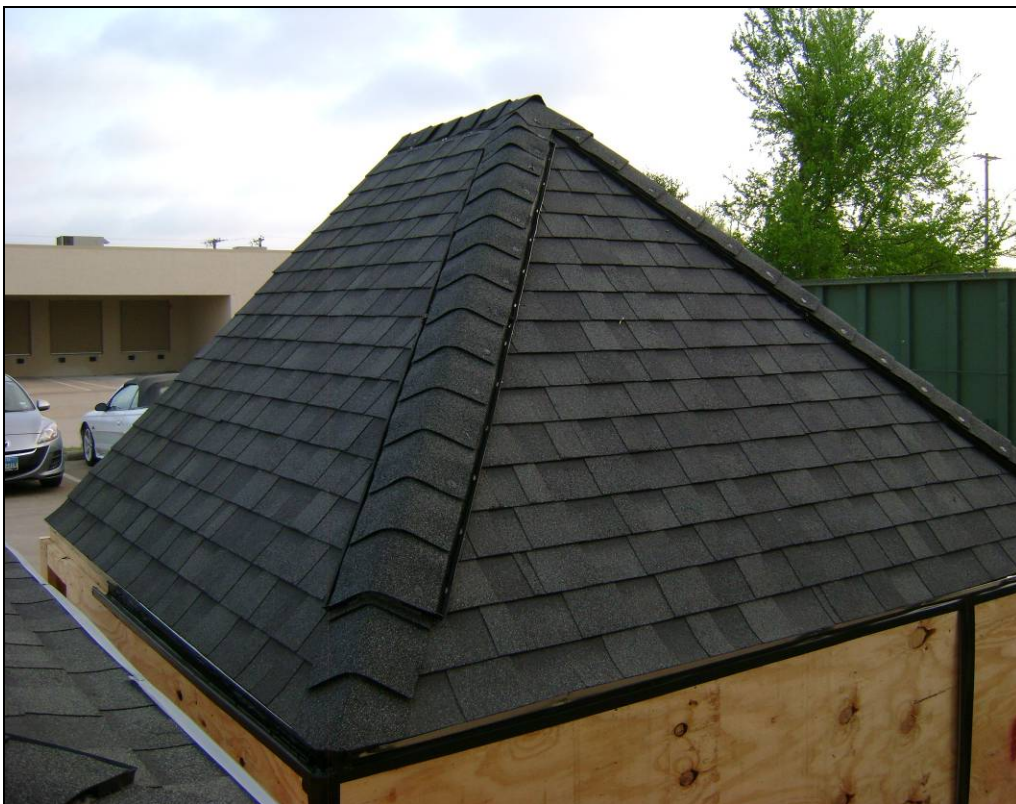
Photo No. 4: Specimen #2 - Prior to testing

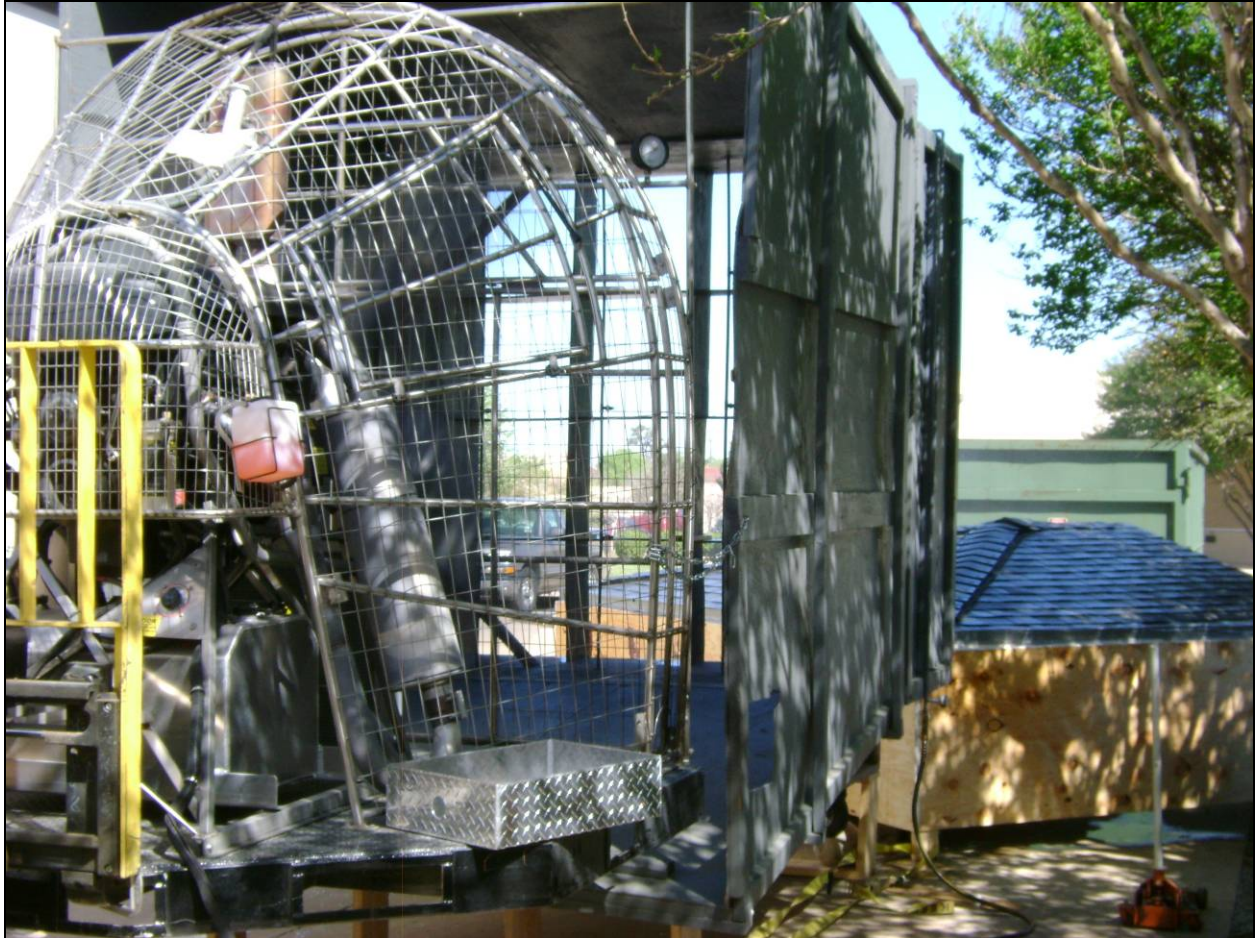
Photo No. 5: Wind generator and wind stream plenum (Specimen #1 in background)

Wind and Rain Supply: Gas engine-powered 7' diameter wind generator with calibrated water spray distribution system. Water spray was calibrated to 4.3 gallons per minute. Calibrated area is 8' x 8'.

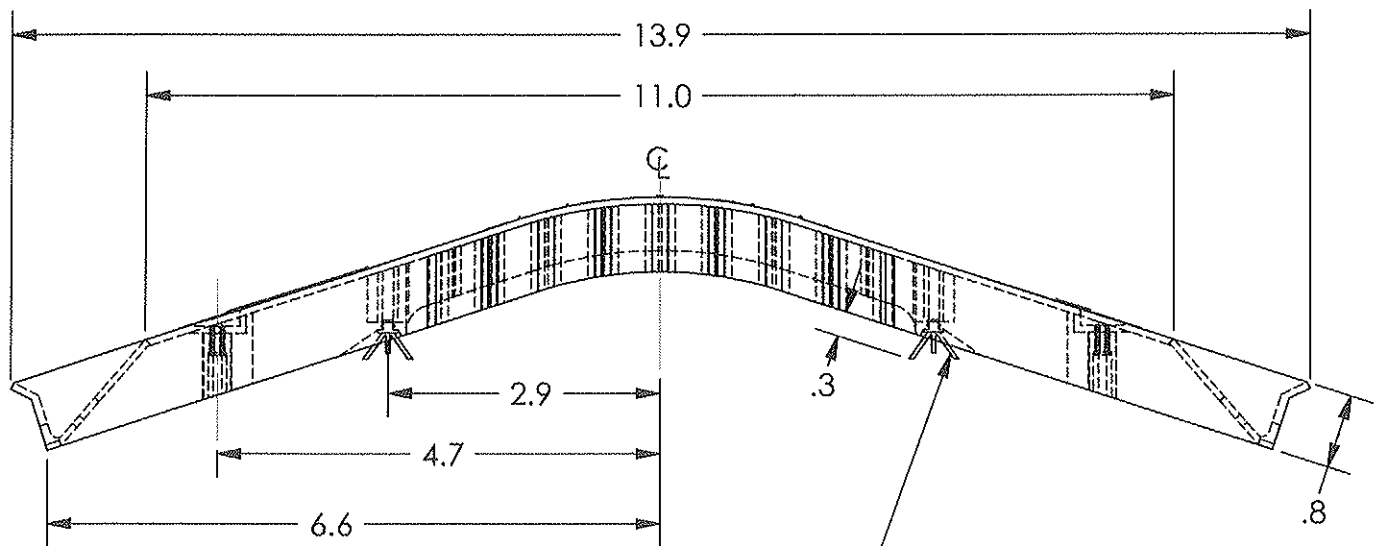
Integrated Gasket
(2 Per Vent)

AV AIR VENT INC. DALLAS, TEXAS	
DIMENSIONS ARE IN INCHES UNLESS OTHERWISE SPECIFIED DO NOT SCALE DRAWING	DESCRIPTION: Hip Ridge Vent Specification Drawing
DRAWING NUMBER: C-84742	MODEL NUMBER: HIPVBL
PREP: A. Lindahl DATE: 5-7-2010	
THIRD ANGLE PROJECTION

Vent Configuration: The vent was a plastic matrix. It was supplied in 48" sections. Two 48" sections were installed together to make a 96" long vent.
