# A Word of Caution About Bathroom Ventilation

## Is Moisture Being Properly Exhausted to the Outdoors?

*Originally Published in Roofing Magazine, April 6, 2022 Photo courtesy of Roofing Magazine*

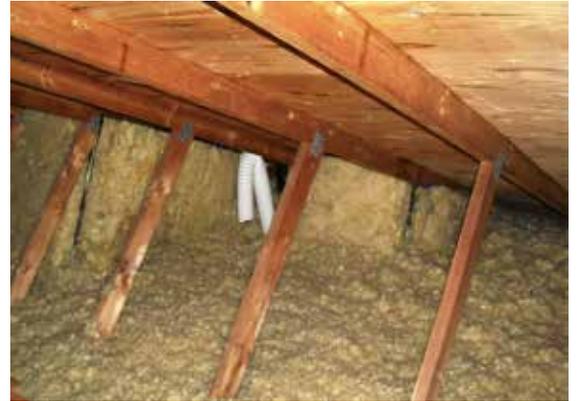
Common ventilation mistakes include bathroom fan ductwork terminating in the attic.  
Photos: Barry Sigler

### Mistake 1: Ductwork Terminating Directly Into the Attic.

When the ductwork from the bathroom exhaust fan terminates in the attic – instead of the outdoors as code states – it brings excessive moisture into the attic that could cause problems. Although attic ventilation is designed to help fight moisture buildup (as well as heat buildup), this amount of moisture is just too much.

“This mistake is fairly common,” Sigler says. “This moisture is now inside the attic, where it can settle. Too much moisture can cause the wood framing inside the attic to rot. During very cold days it can frost on the underside of the roof deck. It’ll rust the nails the shingles are attached with that are sticking out through the underside of the roof deck. It’ll drip from the nails and from the underside of the roof deck onto the insulation.”

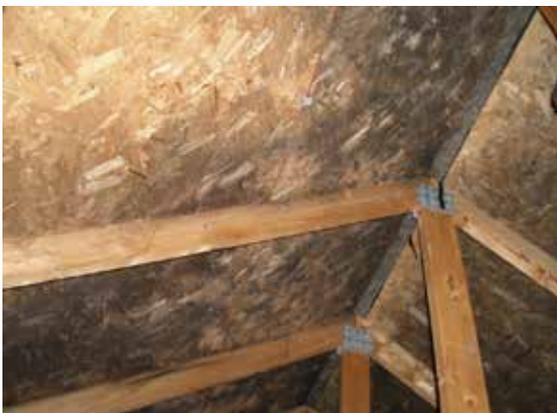
Note the discoloration under the decking,

“I often see a crusty layer on top of the insulation which indicates it has been wet a lot – and maybe dry when I see it,” Sigler continues. “But if I put my hand through it, it’s almost a totally different color underneath the layer of crust. It’s actually compacting the insulation to a degree and making it less effective.”

Sigler says a fully operational and balanced attic ventilation system of intake and exhaust vents is no match for this excess moisture. “That’s usually what I see. The moisture is too much for the attic vents to handle,” he notes. “It often can lead to mold growth as a result. I’ve seen every piece of wood inside the attic black. That’s not good.”

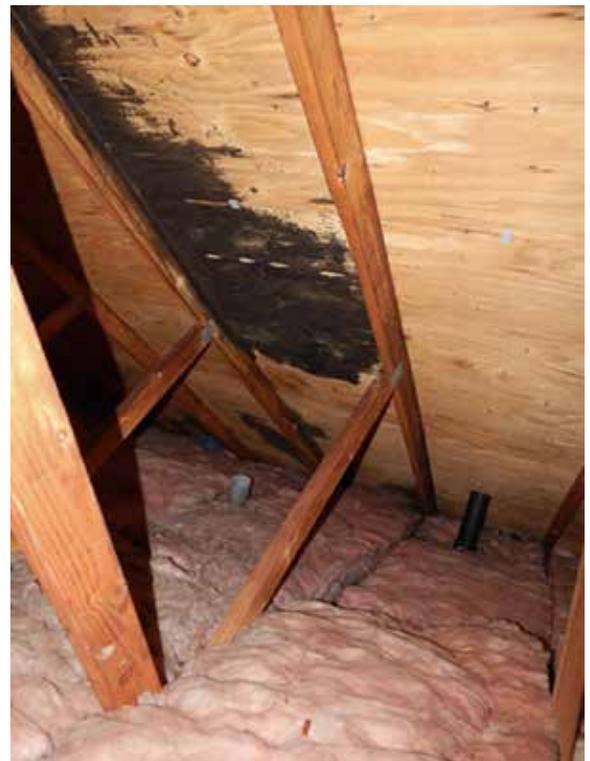
Excess moisture from improperly vented bathroom fans can result in mold growth.

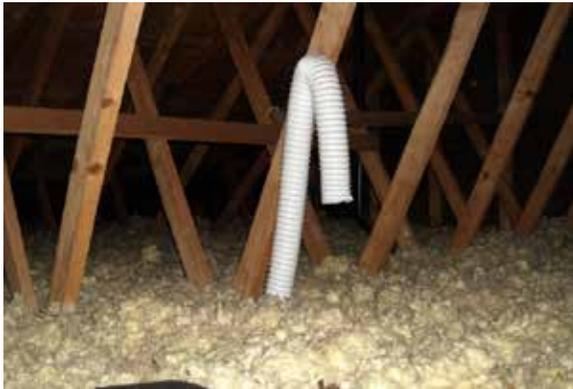
Excess moisture from improperly vented bathroom fans can result in mold growth.
